September 28, 2022

Re: Mold screening inspection report:
Tank Hall, Keep Cottage and Harkness House
Oberlin College, Oberlin, Ohio

Tank Hall Inspection Photos

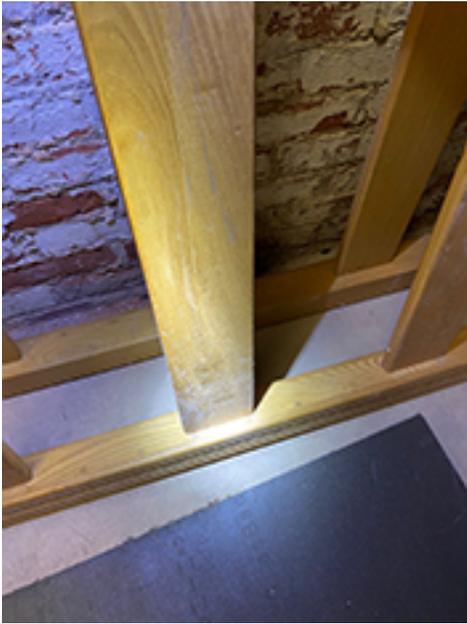
Mold on headboards in basement

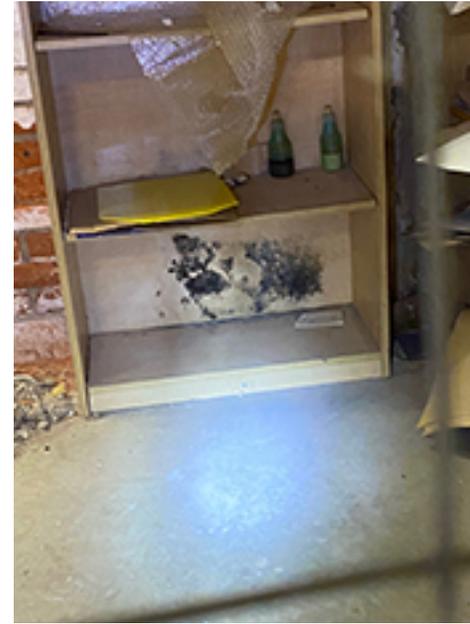
Mold on shelf in basement

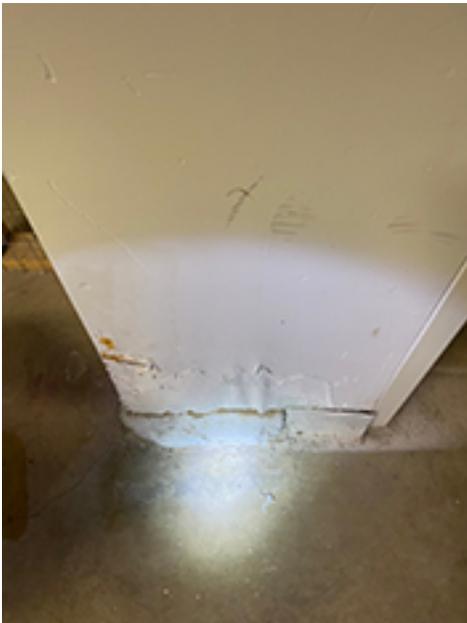
Water damaged drywall in basement with likely mold behind it

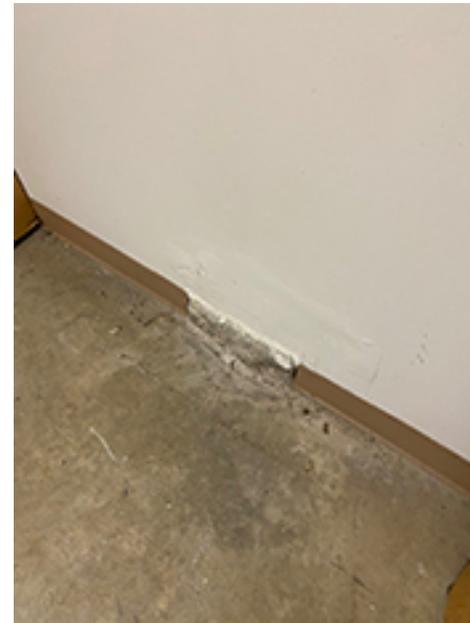
Water damaged drywall in basement with likely mold behind it

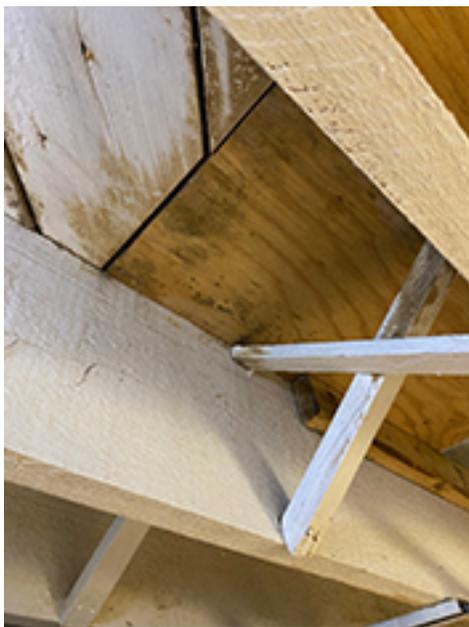
Mold on decking in basement storage room

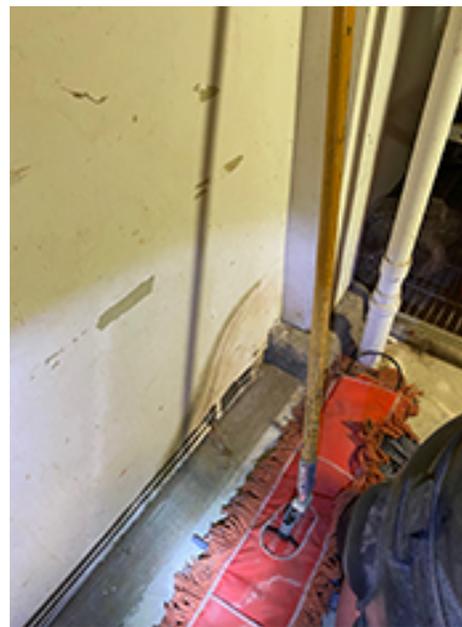
Water damaged drywall in basement with likely mold behind it

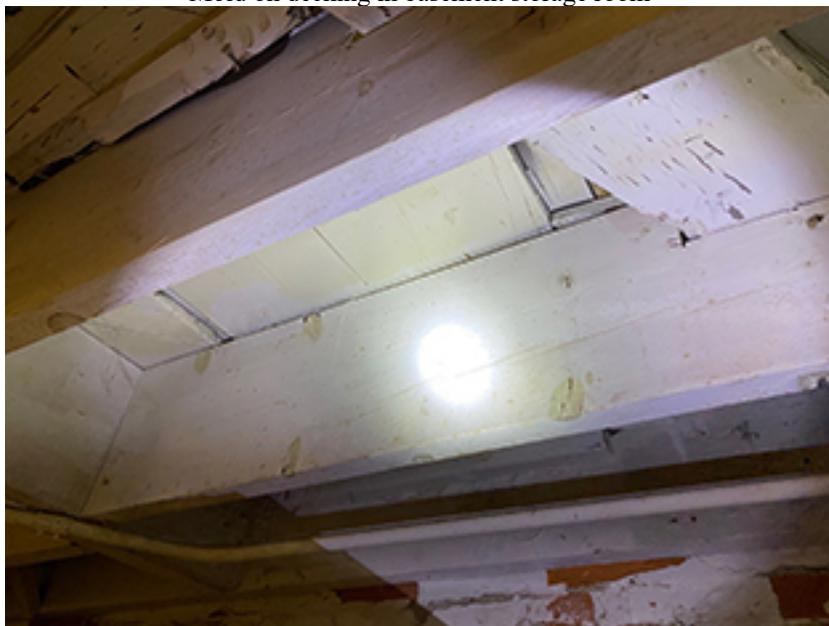
Likely mold on joists in basement storage room

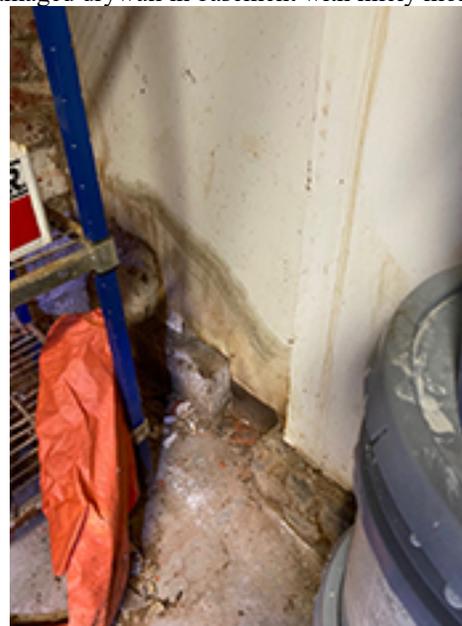
Water damaged drywall in basement with likely mold behind it

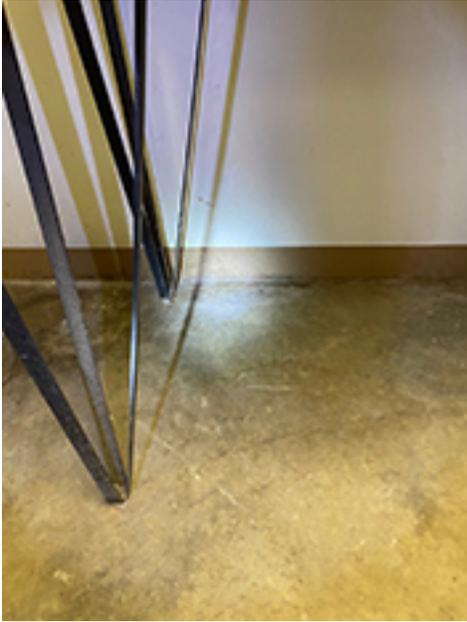
Likely mold in drywall in laundry room in basement

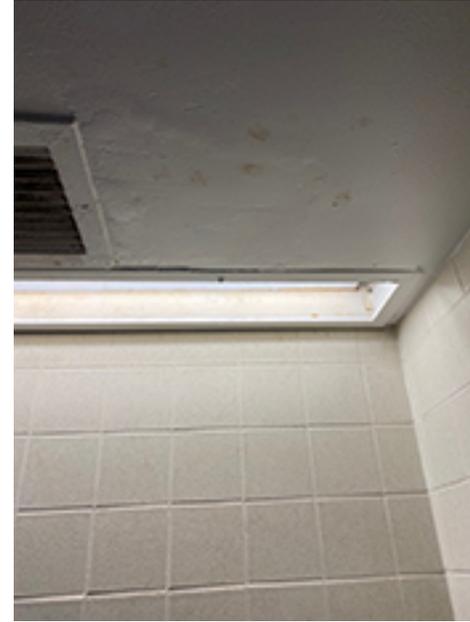
Likely mold on ceiling in bathroom

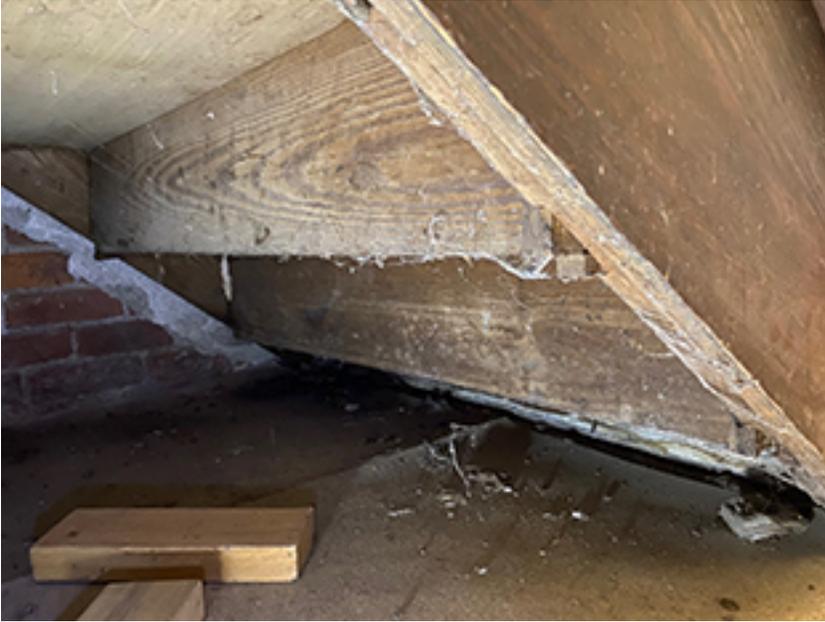
Mold growth under northwest stairs to the basement

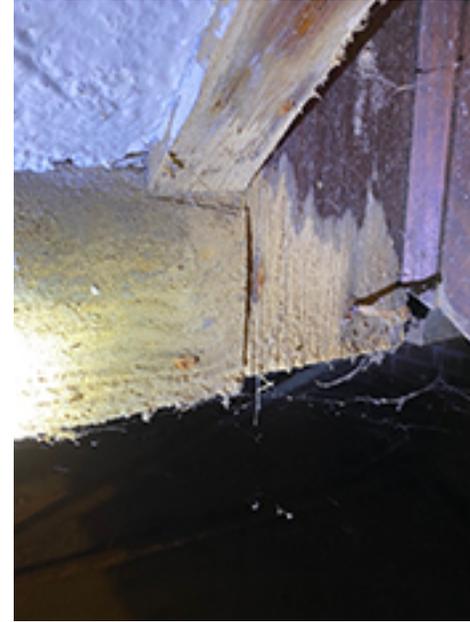
Mold growth under northwest stairs to the basement

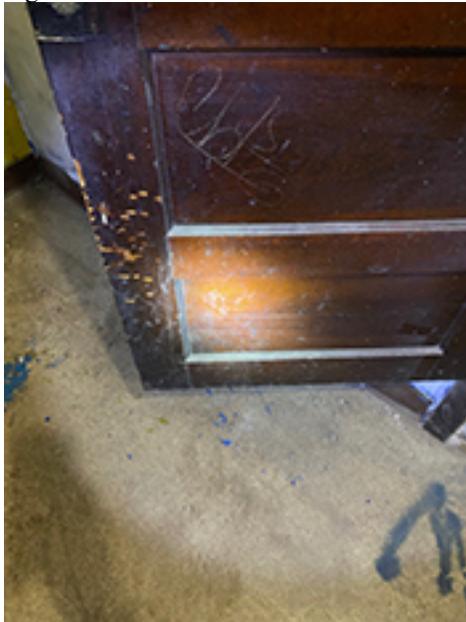
Mold growth on door by northwest stairs to the basement

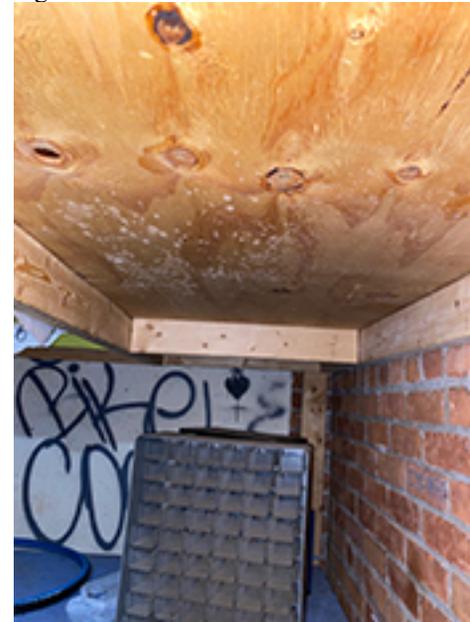
Mold growth under storage shelves by northwest stairs to the basement

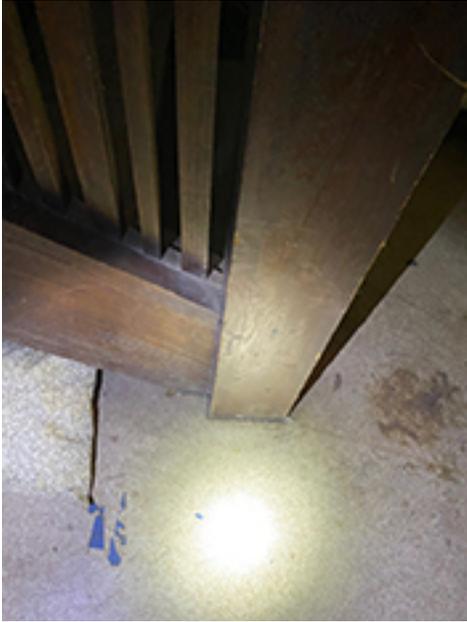
Mold growth on northeast stairs to the basement

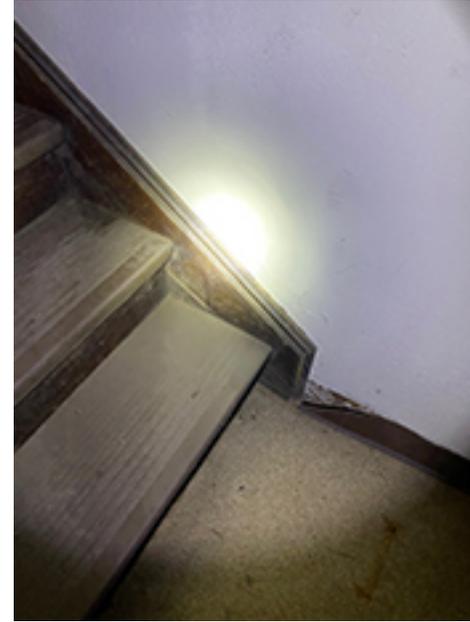
Mold growth on northeast stairs to the basement

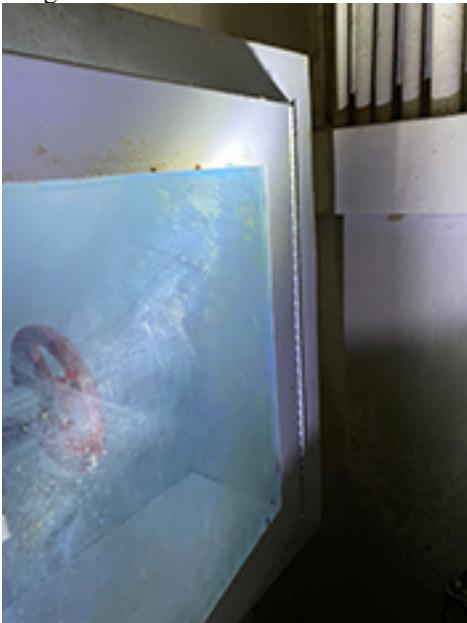
Mold growth on fire line valve box in northeast stairwell to the basement

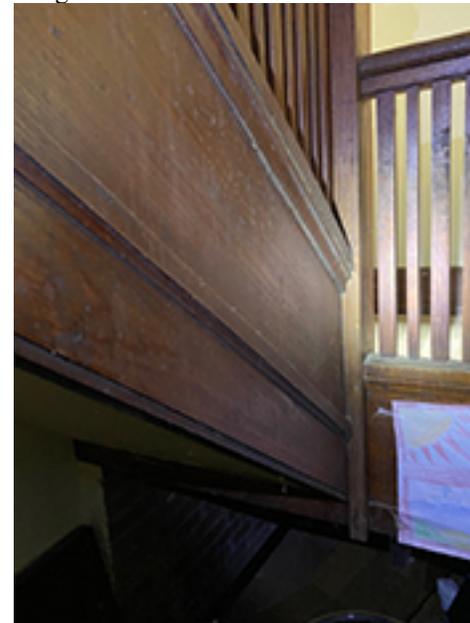
Mold growth on northeast stairs to the basement

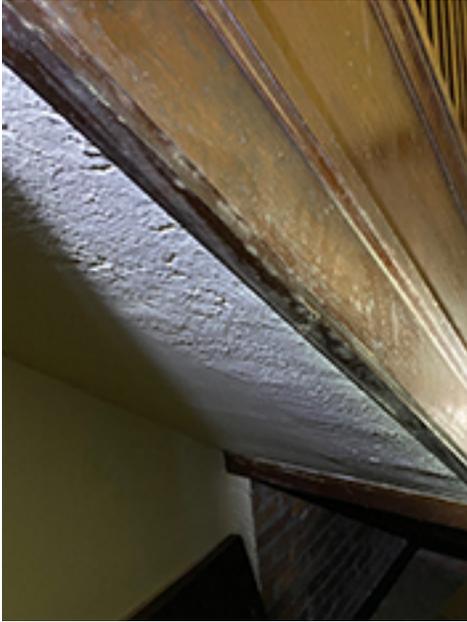
Mold growth on northeast stairs to the basement

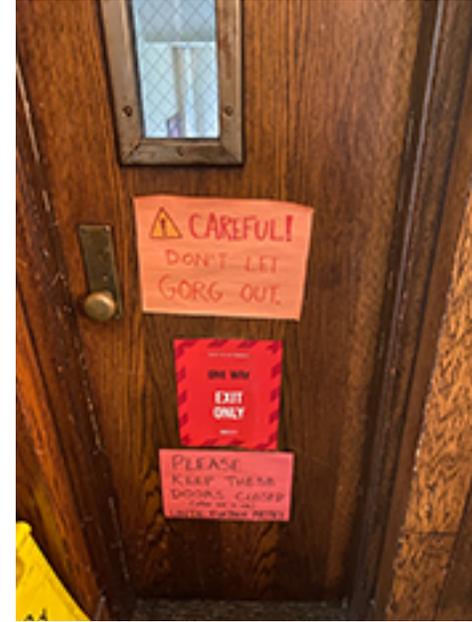
Student note regarding unhealthy conditions in the northeast basement stairwell

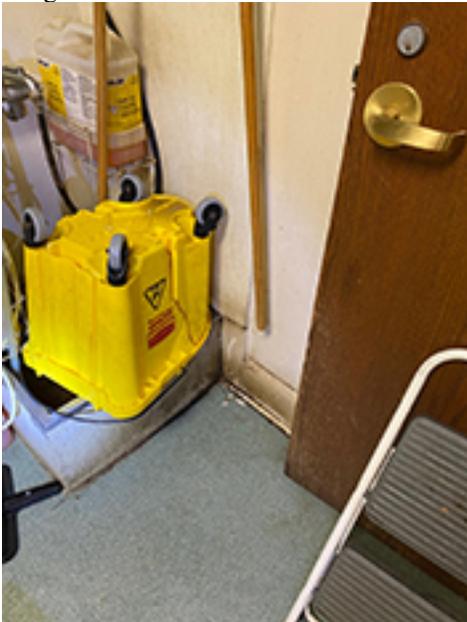
Water damage to drywall by mop sink in HVAC room

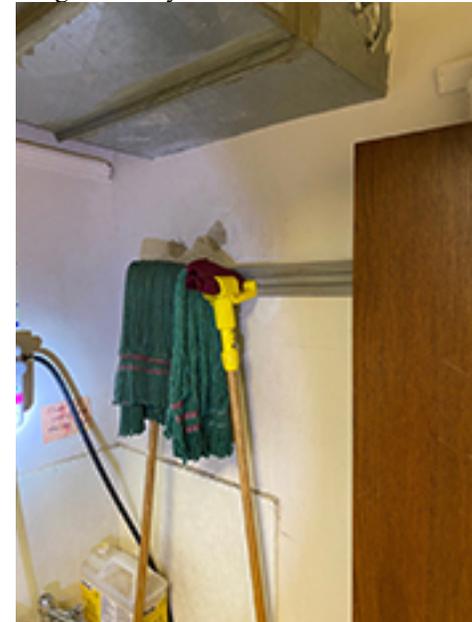
Water damage to drywall by mop sink in HVAC room

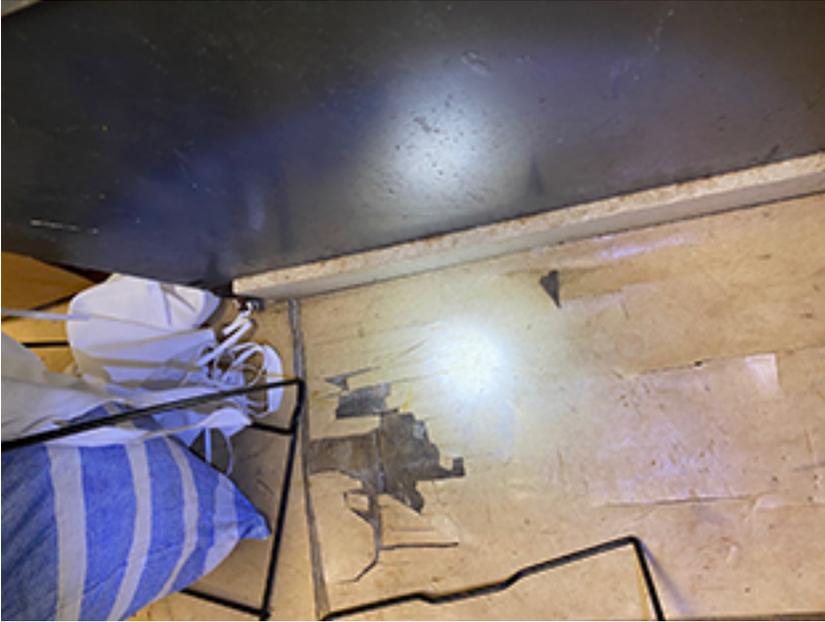
Water damage to wood floor in HVAC room

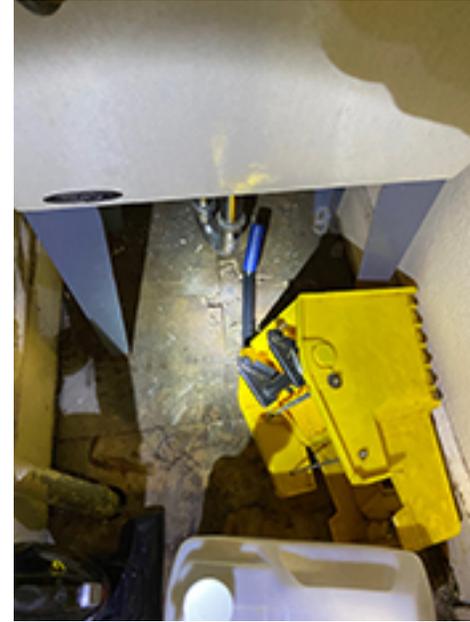
Water damage to wood floor in utility closet

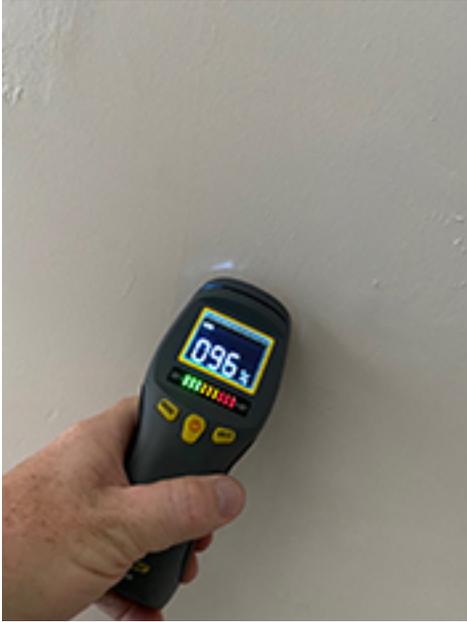
High moisture entrapment behind wallboard under east stairs to the basement

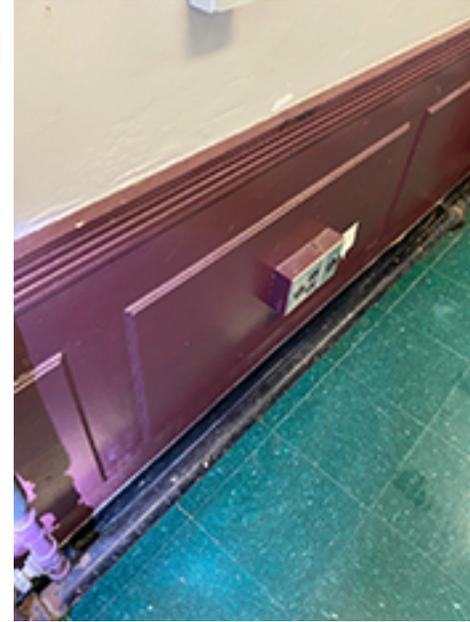
Wainscoting in dining room with evidence of moisture entrapment

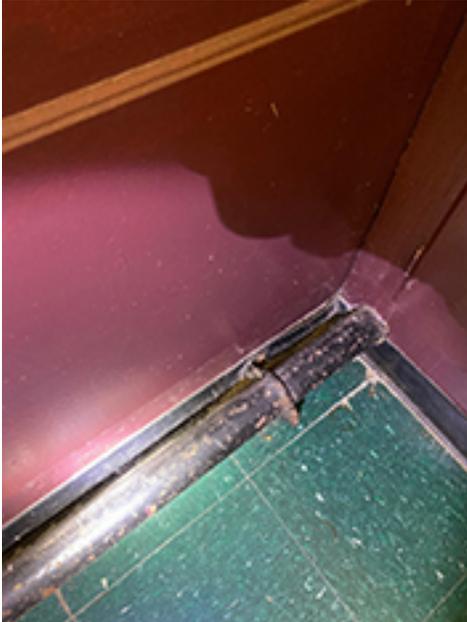
Some visible mold growth on dining room wainscot

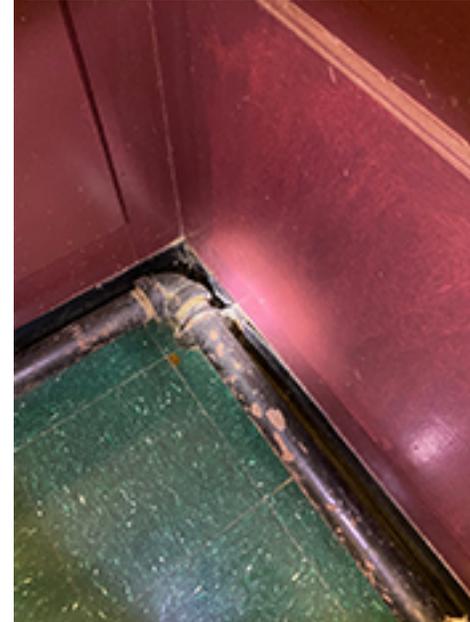
Some visible mold growth on dining room wainscot

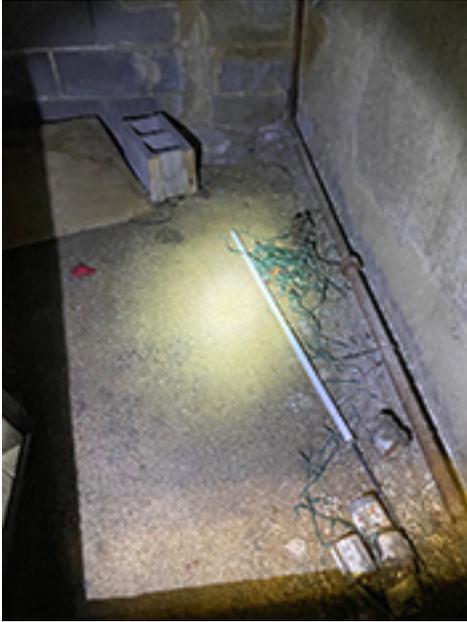
Mold carper remnant in basement mechanical room

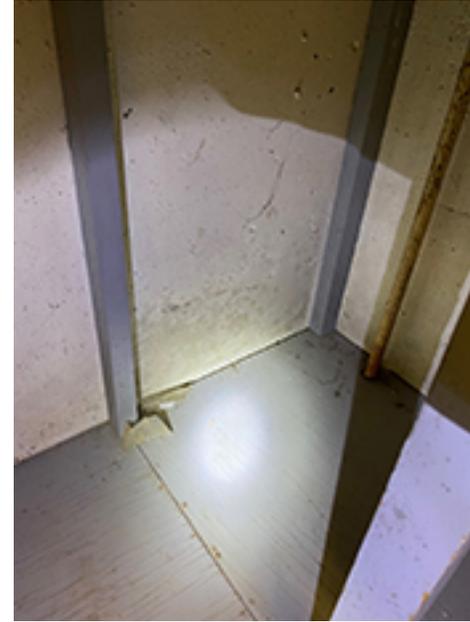
Mold growth on walls in basement mechanical room

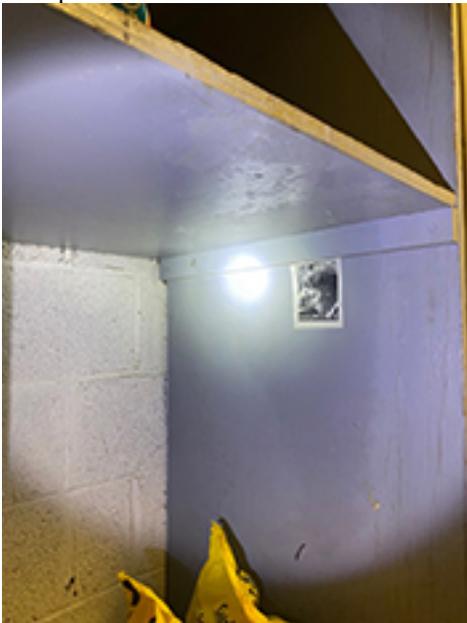
Mold growth on shelves in basement mechanical room

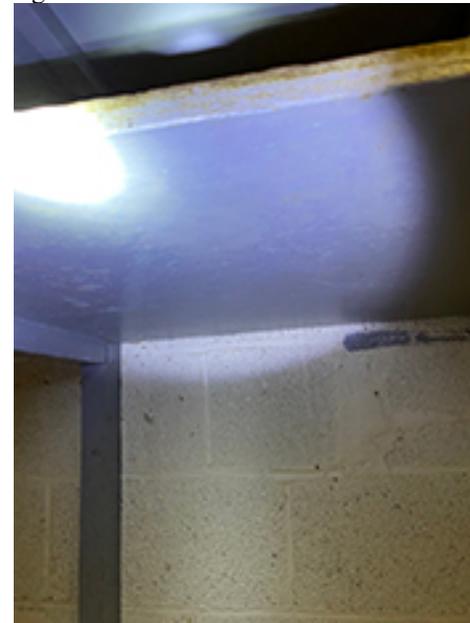
Mold growth on shelves in basement mechanical room

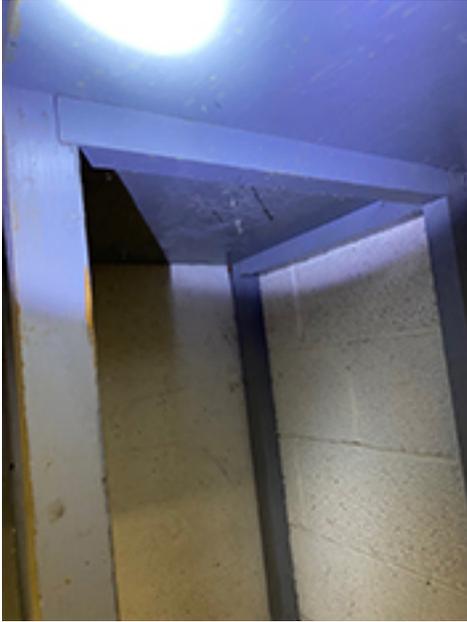
Mold growth on shelves in basement mechanical room

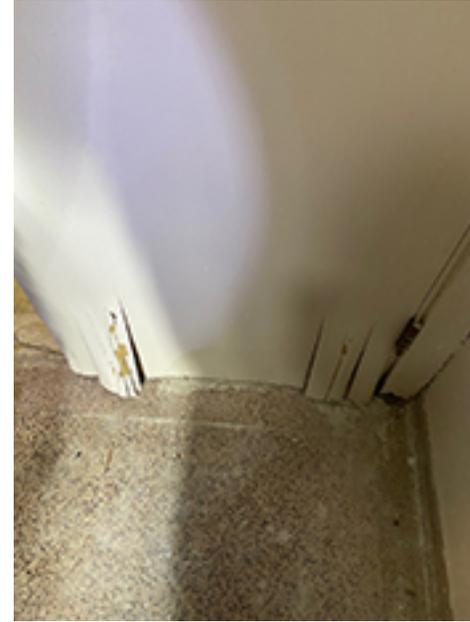
Water damage on door by to Barbie Thompson's office

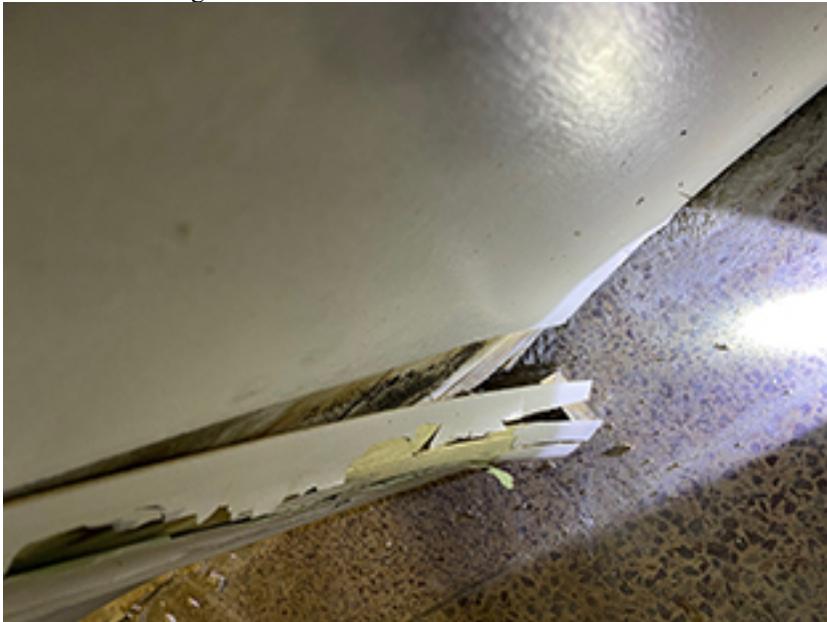
Mold growth on door by to Barbie Thompson's office

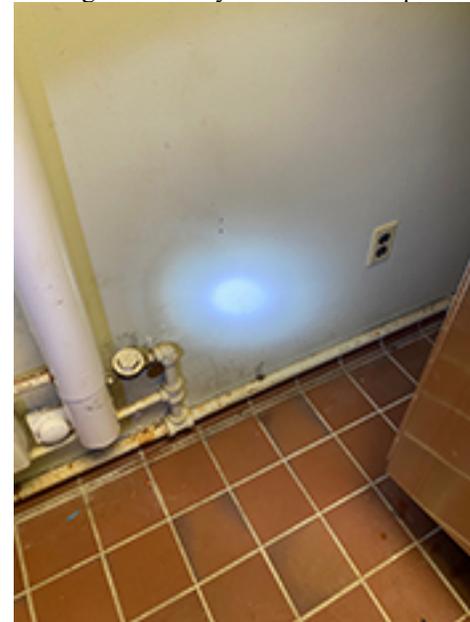
Mold growth on wall in kitchen food storage area

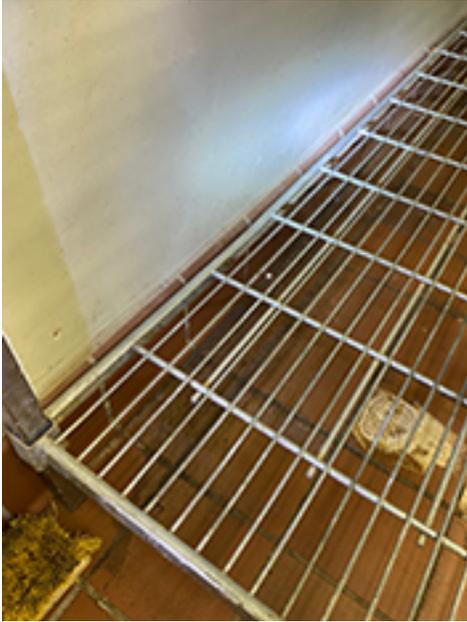
Mold growth on wall in kitchen food storage area

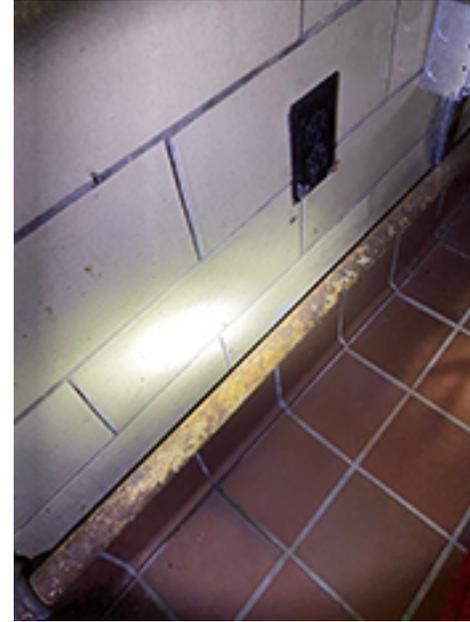
Mold growth on wall in kitchen food storage area

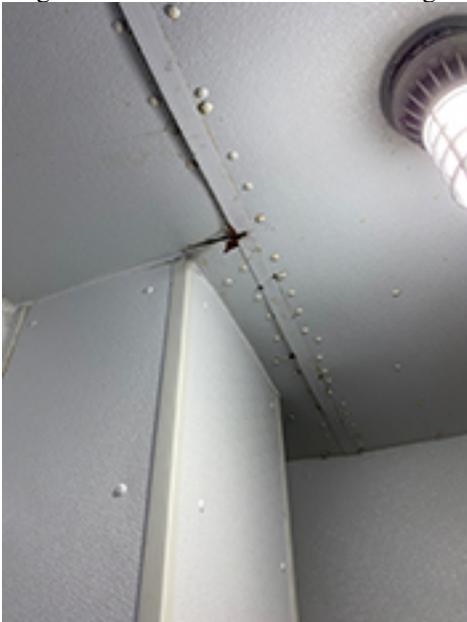
Fungi growing from ceiling in food storage cooler

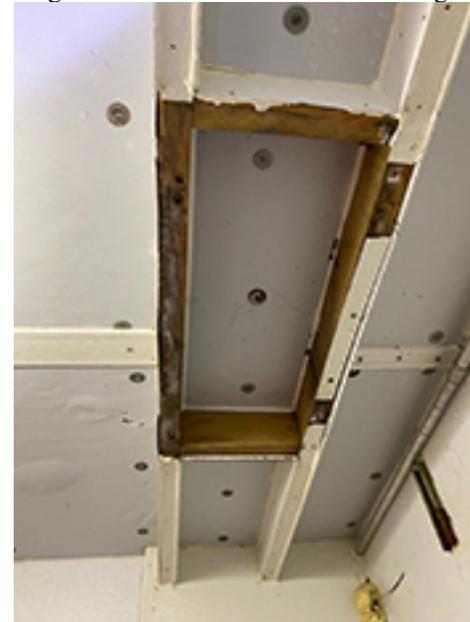
Mold on wood in ceiling in food storage cooler

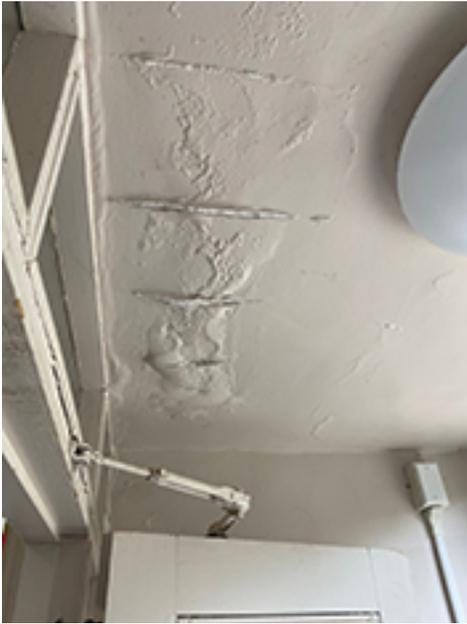
Water damaged ceiling at east entrance to Harkness House

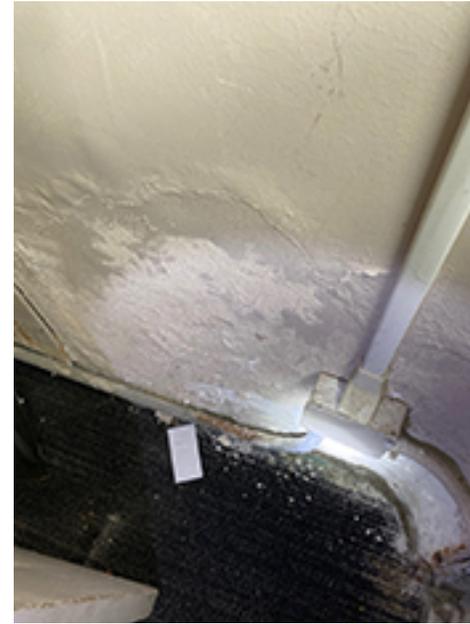
Water damaged wall at east entrance to Harkness House

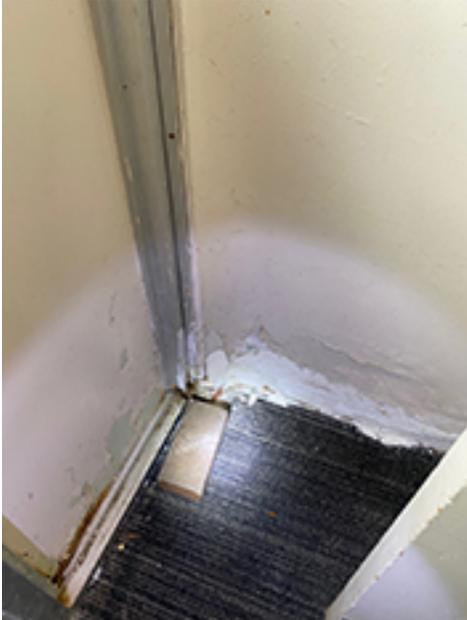
Water damaged partition at east entrance to Harkness House

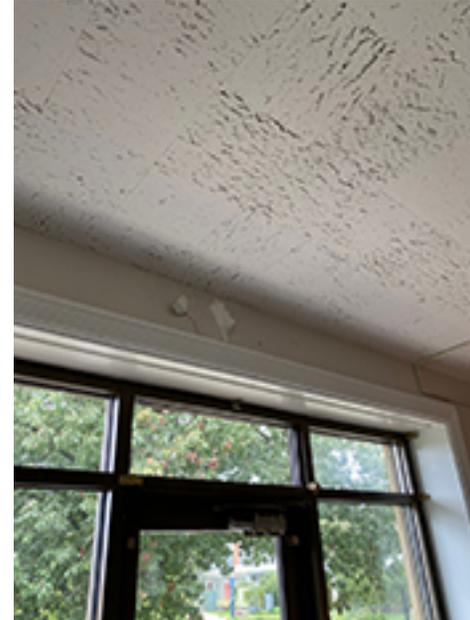
Water damage above windows in study hall, west side, main floor

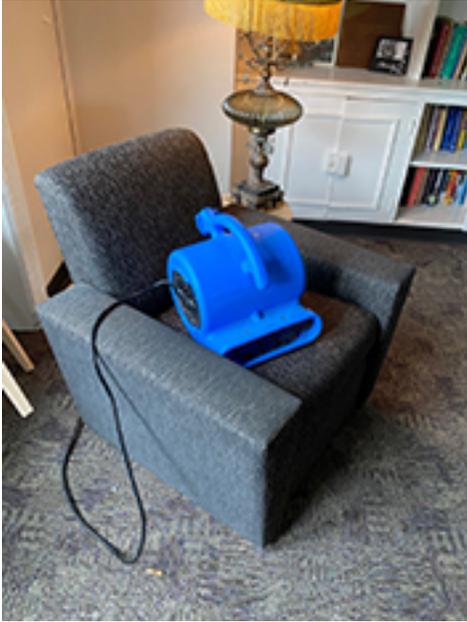
Industrial drying fan in study hall suggesting attempts to resolve water intrusion

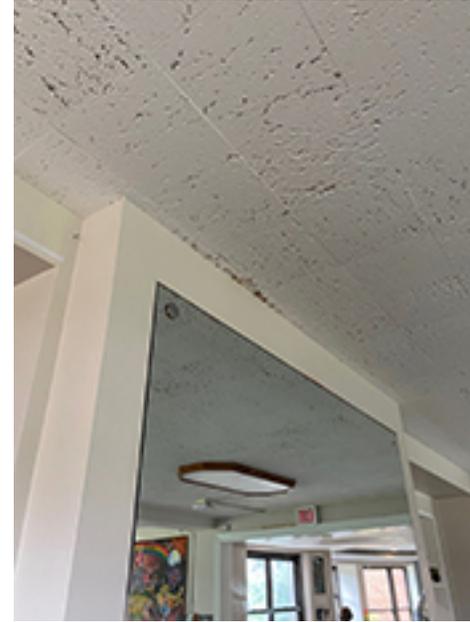
Water damage on ceiling in the study hall

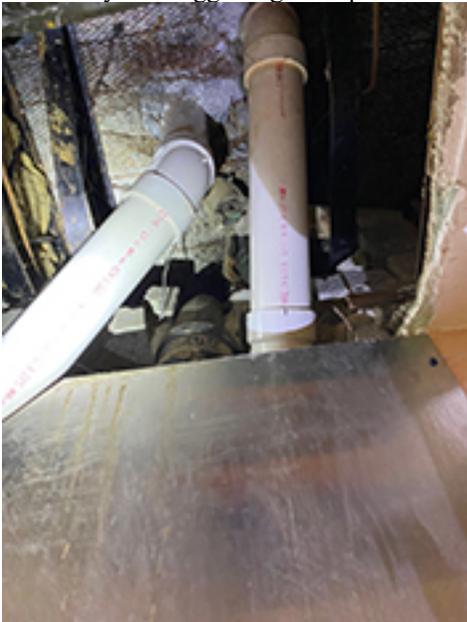
Exposed presumed asbestos pipe insulation in utility closet

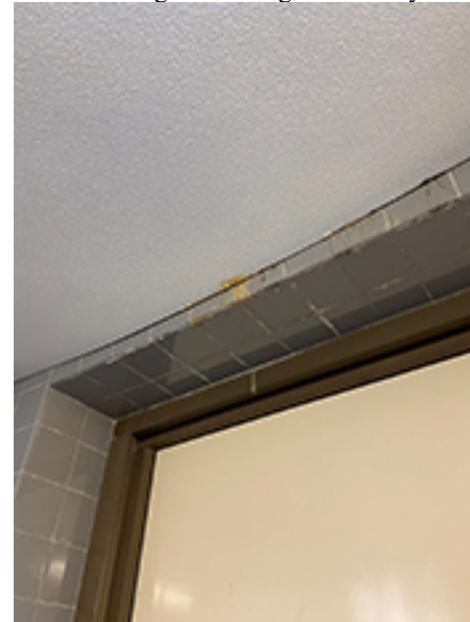
Active water leak in bathroom hidden by fiberglass panel

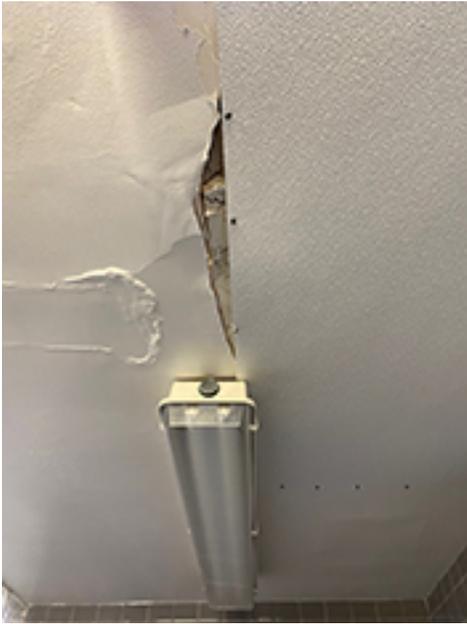
Active water leak in bathroom hidden by fiberglass panel

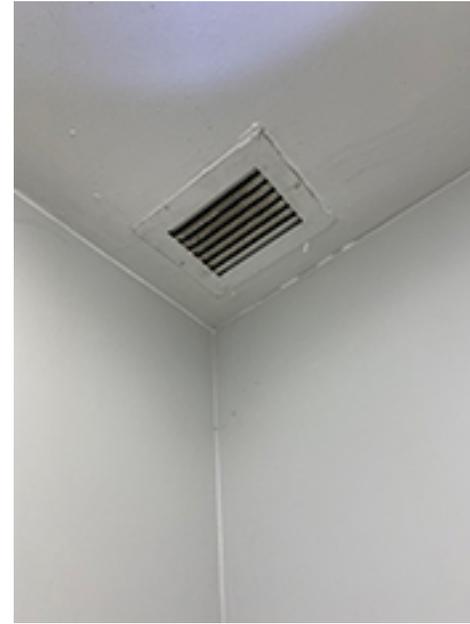
Dirty return grill in bathroom

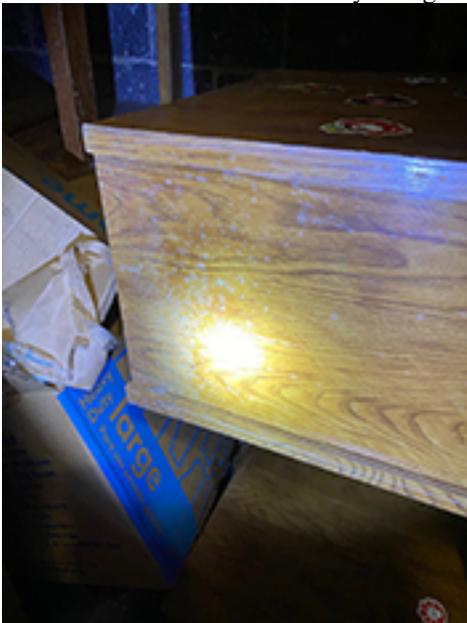
Moldy furniture in hallway storage closet

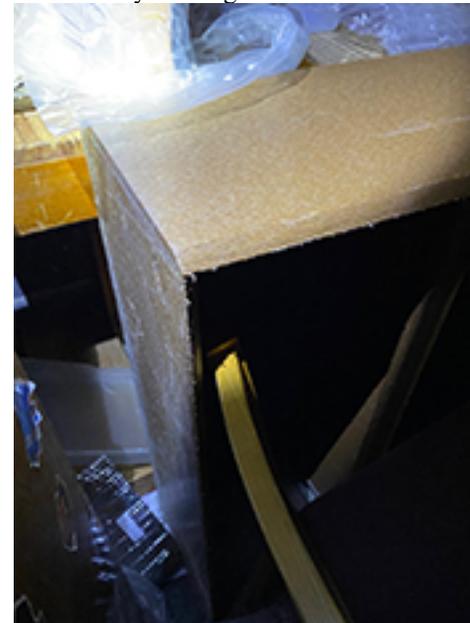
Moldy furniture in hallway storage closet

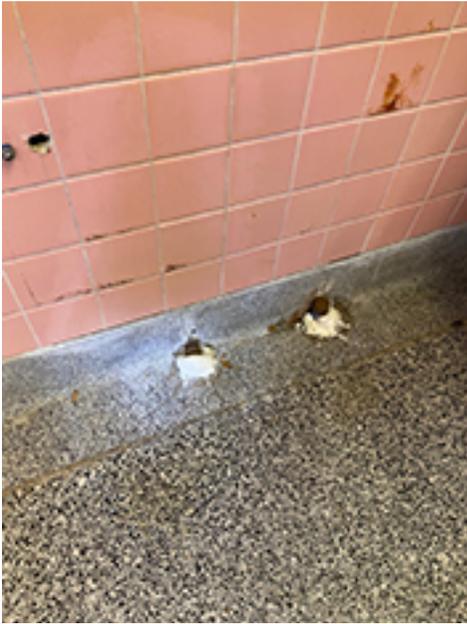
Insulating foam attempt to control water leak

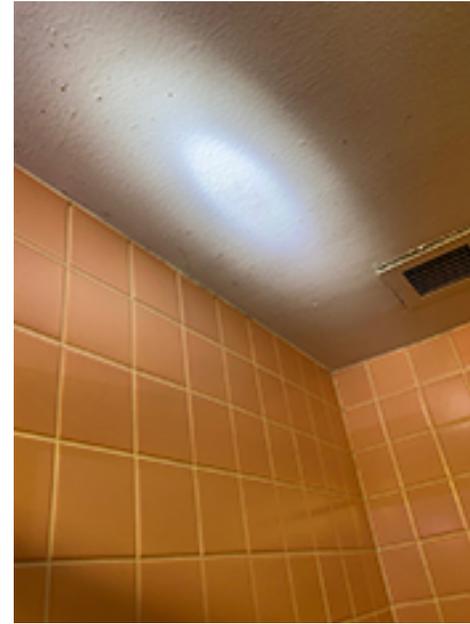
Suspected mold growth on ceiling in bathroom shower

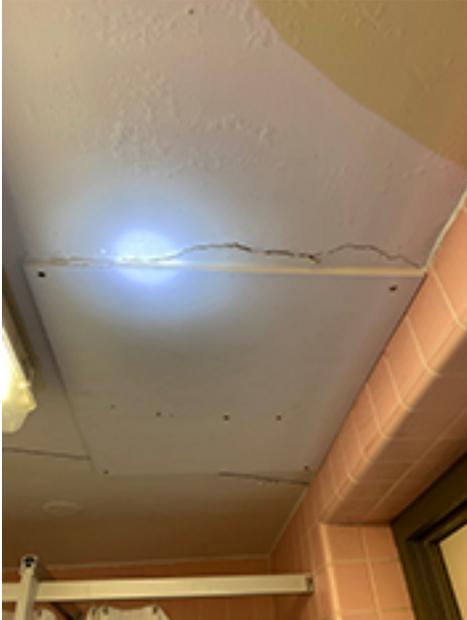
Another improvised patch of ceiling in bathroom to mask water leak

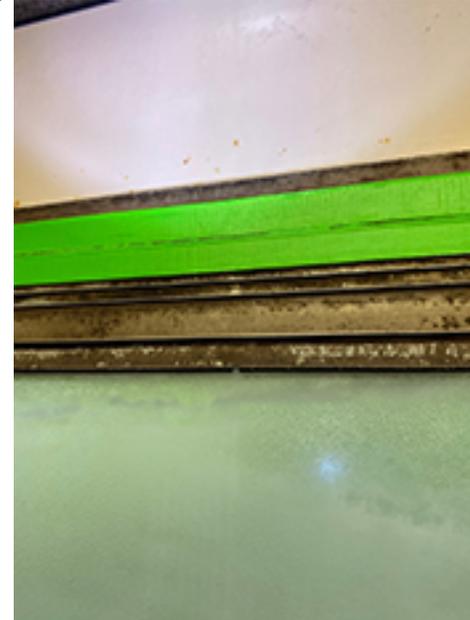
Mold growth on window frame in bathroom

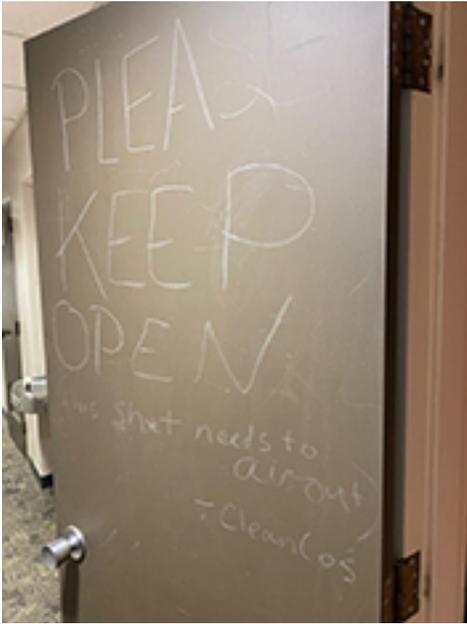
Student note in an attempt to help control odors resulting from trapped moisture
